# Gateway Housing Association – Victoria Court External Repairs & Redecorations

## Solution-Finding Approach Secures Safe & Compliant Homes for Sheltered Housing Residents

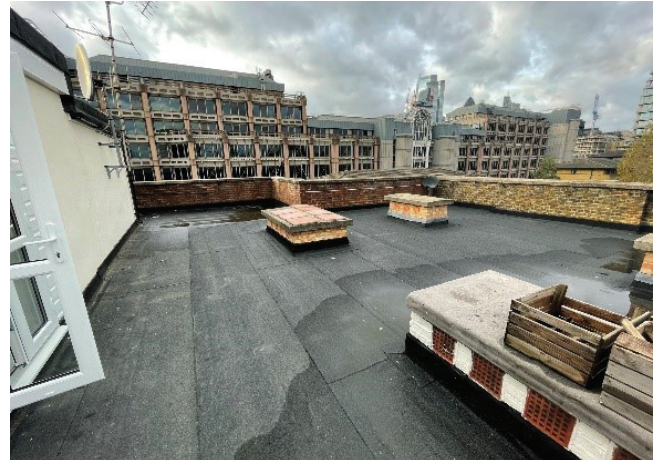
When the existing roof covering was removed, it was found that the internal waste pipes had been leaking from a converted penthouse flat, which explained an historic damp problem in parts of the building. The leak had penetrated beneath the roof level and down the walls of some of the lower level flats.

The leaking pipe was situated behind a tiled bathroom wall in one of the flats, which made it challenging to identify the problem, as well as resolve it in a timely manner so further damage could be avoided.

We needed a least-disruption solution to fixing the leaking pipe. So, instead of knocking through the walls in the affected flats to access it, we decided it would be better to redirect the pipe upwards, so that the defective part sat above roof level. This approach would prevent the leak from saturating the walls in the lower level flats.

We instructed the contractor, Axis Europe, to box in the raised pipes, not just to improve the aesthetic, but also to provide straightforward access should the pipes present further problems in the future. The approach was a success, with the leak being stemmed and the walls of the affected flats beginning to dry out. This was closely monitored over time to ensure the problem had been resolved.
